EXHIBIT MPWMD-TC15

MONTEREY PENINSULA WATER MANAGEMENT DISTRICT

**RIPARIAN CORRIDOR MONITORING REPORT
CARMEL RIVER
2004**

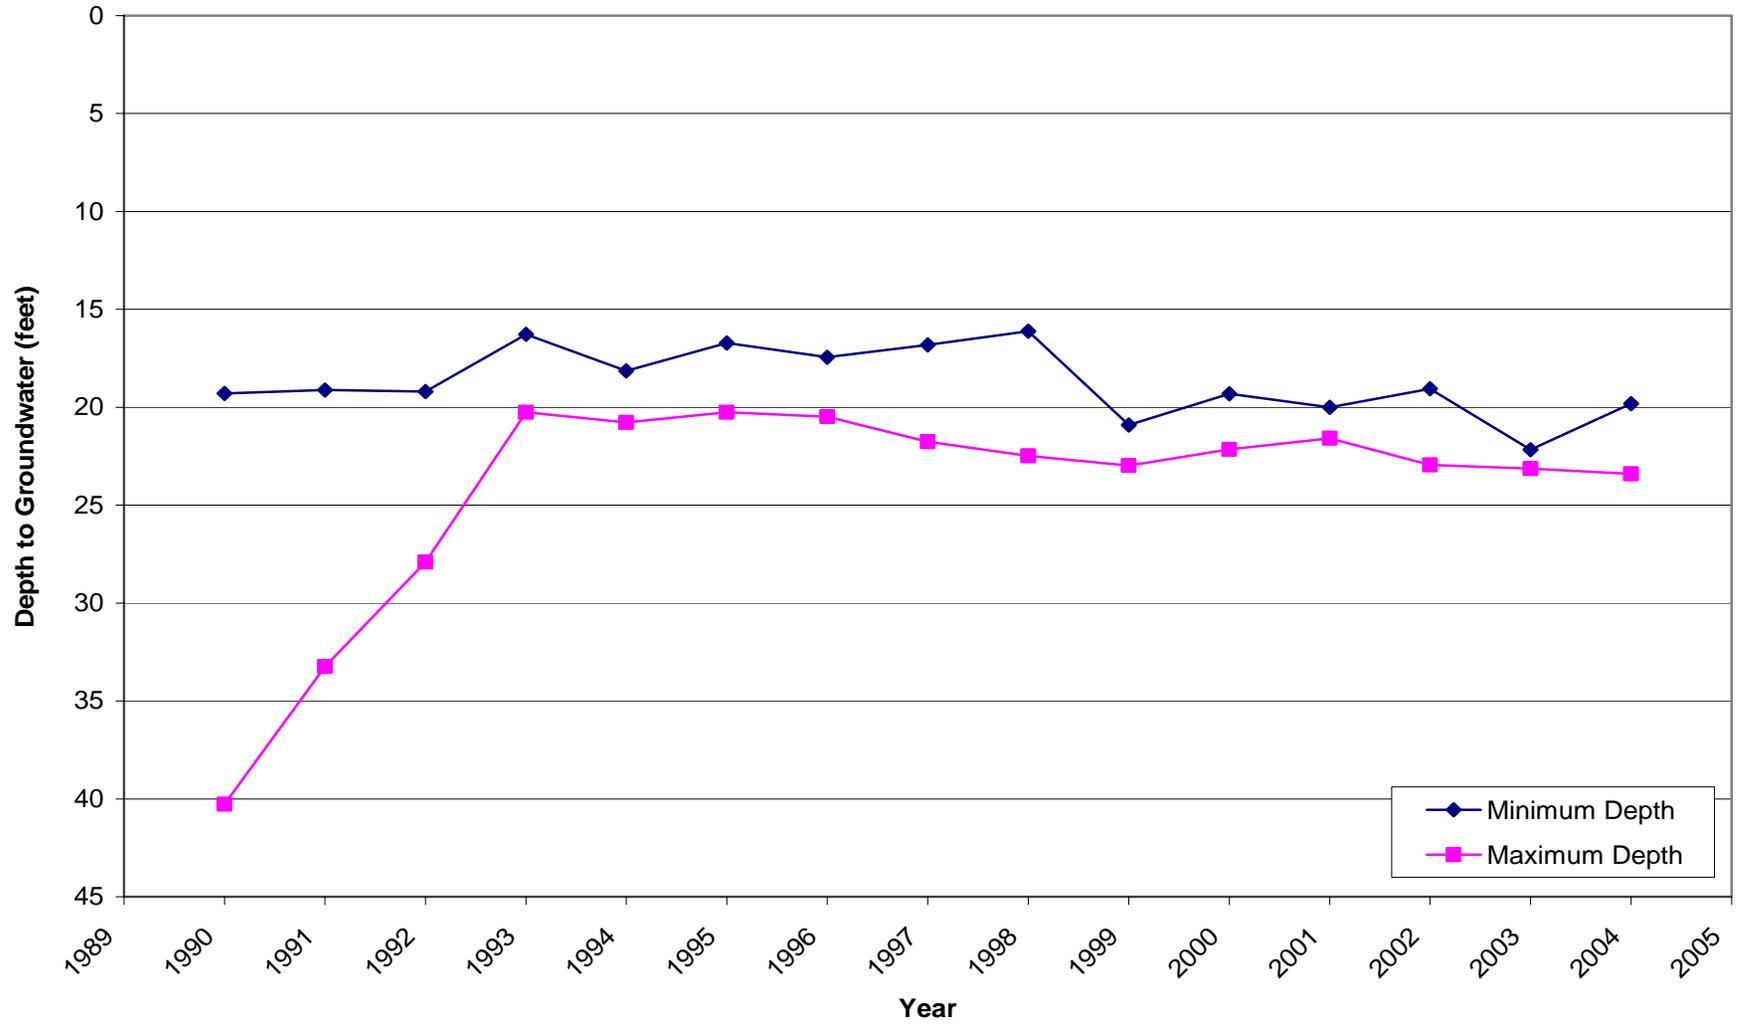
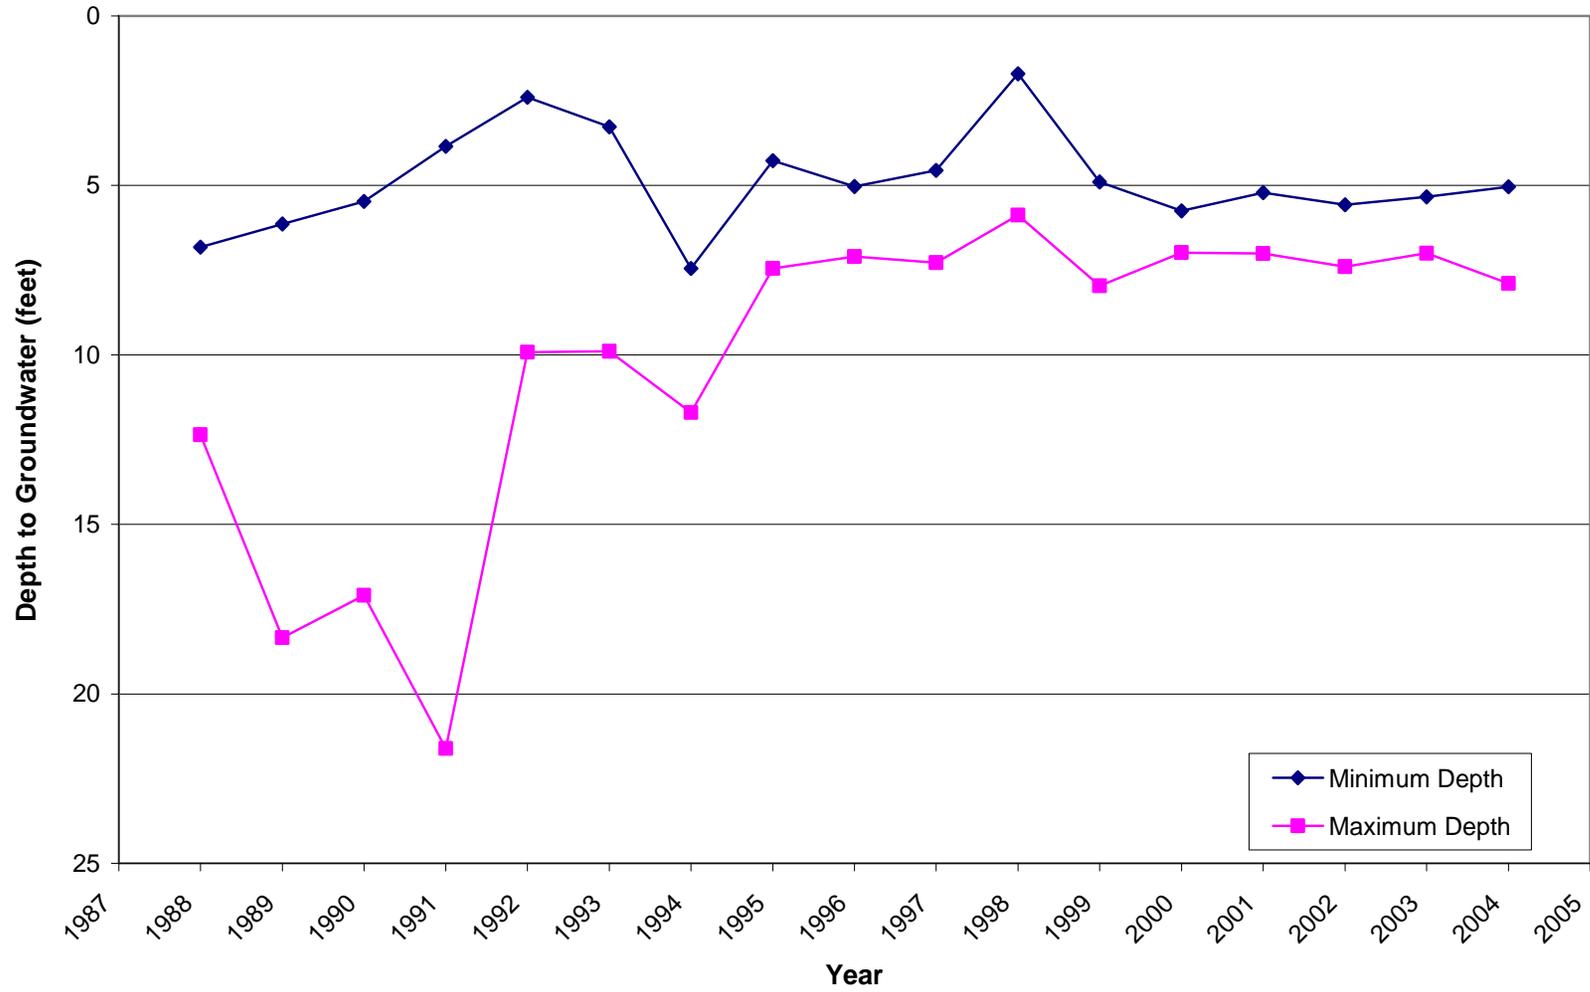
APPENDIX A: Historical Depth to Groundwater for Selected Monitoring Wells

Historic depth to groundwater values from 1988 through 2004 were plotted for six monitoring well sites; de Dampierre, Coyote, Reimers, San Carlos, Rubin, and Highway 1. These plots provide baseline data for each monitoring site, indicating minimum and maximum groundwater depths from 1988 through 2004 (See Appendix A for historic depth to groundwater plots). The annual variation in depth to groundwater is mostly a function of annual precipitation, stream flow, and municipal pumping regimes. Extreme groundwater levels that are observed to exceed historic maximum depth can justify the application of irrigation to mitigate stress on riparian vegetation.
